Weight and Balance Behavior of a Freighter Aircraft During Cargo Fire Test Evaluations

DOT/FAA/TC-TN13/51

16. Abstract The Federal Aviation Administration Airport Technology Research & Development Branch conducted a Full-Scale Cargo Fire Research Project that involved a series of firefighting-related tests with an Airbus A310 cargo aircraft. One test included a study of the weight and balance characteristics of the aircraft during a fire attack. Aircraft are sensitive to loading configurations; therefore, personnel working on and around the aircraft must ensure the aircraft remains within aircraft manufacturer's recommended weight and balance guidelines during loading and unloading. Aircraft Rescue and Firefighting (ARFF) personnel must be equally aware of these weight and balance guidelines when responding to an aircraft accident or incident. Depending on the severity, impacts or abrupt movements affecting the aircraft during the event can cause a shift in load, which would adversely affect the weight and balance. Freighter aircraft are particularly susceptible to weight and balance issues due to cargo weight and varying locations on the aircraft in which the cargo can be placed

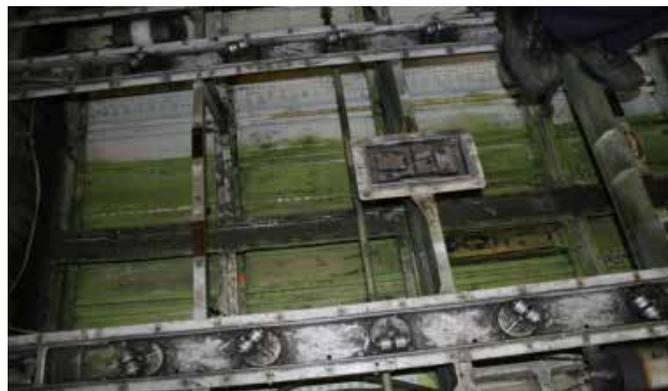
WATER REMOVAL. A change in an aircraft's weight and balance may be due to an accumulation of water in the bilge from firefighting efforts. Figure 3 shows the bilge with the floor removed in an MD-11 aircraft in the FedEx Maintenance Facility at Los Angeles International Airport. An aircraft bilge has a series of drains. The drains are very small, approximately 1/8 inch in diameter, and are designed to release water from condensation or spilled liquid freight. During fire conditions, soot and debris can block the drains. Aircraft are generally designed to have separate forward and aft bilges. This division is created from the space made for stowing the main landing gear. If water enters one bilge, it cannot drain back to the other bilge.

Figure 3. The Bilge of the Aircraft Below the Lower Cargo Compartment With the Floor Removed

The main cargo compartment of the aircraft is equipped with low-volume floor drains routed directly into the bilges. These drains remove rainwater that enters the aircraft through open doors while loading cargo. They also handle any liquid spilled or introduced during aircraft cleaning. During firefighting operations, the amount of water discharged into the aircraft can overwhelm these drains. If enough water builds up in the main cargo compartment, it may eventually flow to drains in the opposite end of the aircraft, causing water to make its way into all bilges.

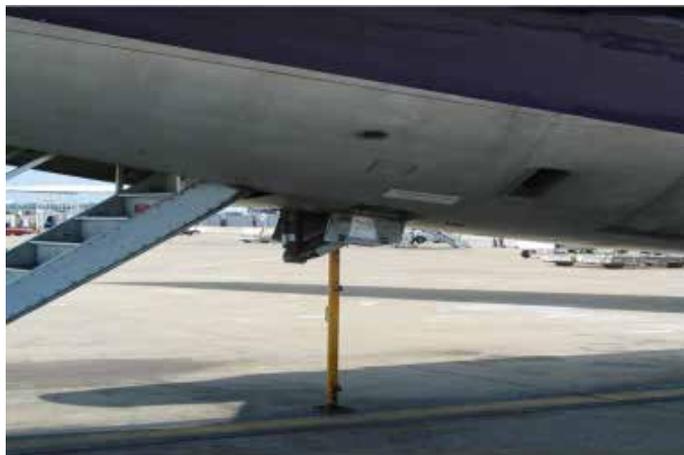
Tail Posts and Tail Stands. Certain aircraft may be equipped to accept a tail post or tail stand. Figure 4 shows a FedEx Boeing 727 aircraft equipped with a tail post. The tail post is not designed to support the tail of an aircraft but to serve as a visual indicator of weight and balance behavior of the aircraft. When installed, it hangs down from the aircraft and does not touch the ground. The distance from the ground changes as the aircraft is loaded. If the aircraft is not designed with a tail post, no attempt should be made to install a tail post because it is likely to cause more damage and create a new safety hazard.

Figure 4. Tail Post Installed on a FedEx B-727

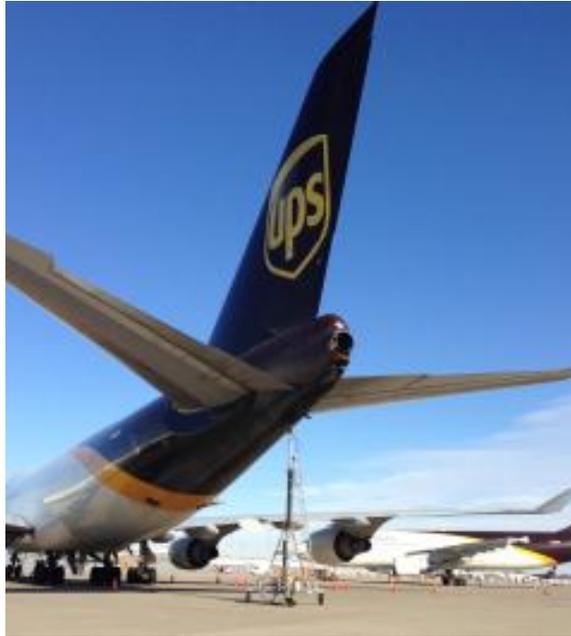
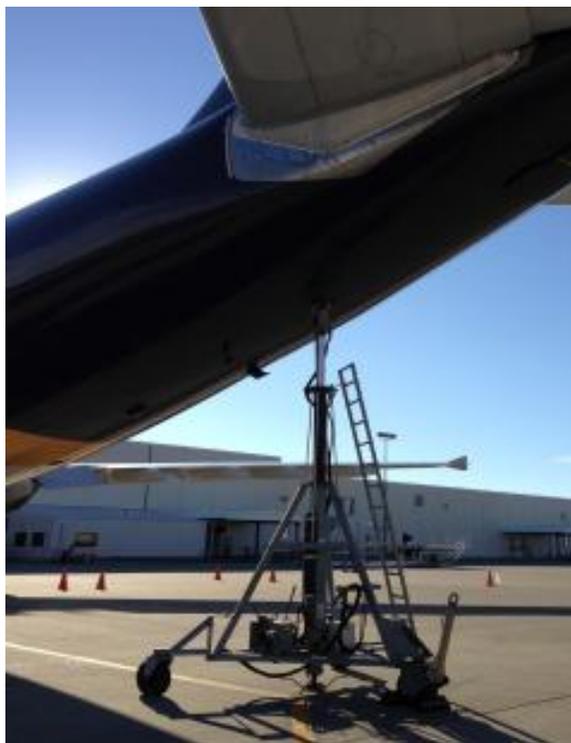
UPS uses a variety of tail stands to support the tail of an aircraft. Tail stands are mounted before loading and offloading operations of certain aircraft. Tail stands sometimes serve as a stabilization tool for an aircraft with an onboard fire. Figures 5 and 6 show tail stands installed on a UPS B-747 and a UPS DC-8, respectively. The tail stands are not placed under the aircraft, but are attached into the receiving system on equipped aircraft. The receiving system is a structurally reinforced mounting point designed to support the part of the aircraft attached to the tail stand. Figure 7 shows the engagement point between the tail stand and the aircraft. A tail stand may be easier to use for stabilizing smaller aircraft. Figure 8 shows a Citation Jet that was involved in an accident with a push back. The tail stand was put in place as part of the aircraft stabilization and recovery efforts.

Figure 5. Tail Stand Attached to a UPS B-747 (Courtesy K. Hoff, UPS Safety)

Figure 6. Tail Stand Attached to a UPS DC-8 (Courtesy K. Hoff, UPS Safety)

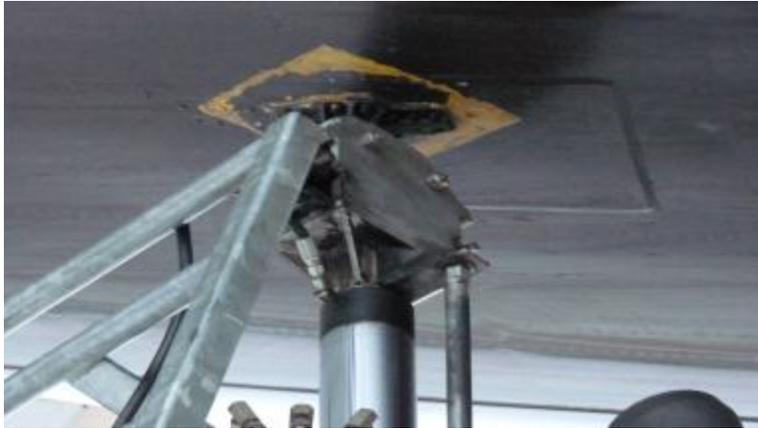
Figure 7. Tail Stand Attachment Point
(Courtesy of Mike Clancy, City of Billings, Logan International Airport, Montana)

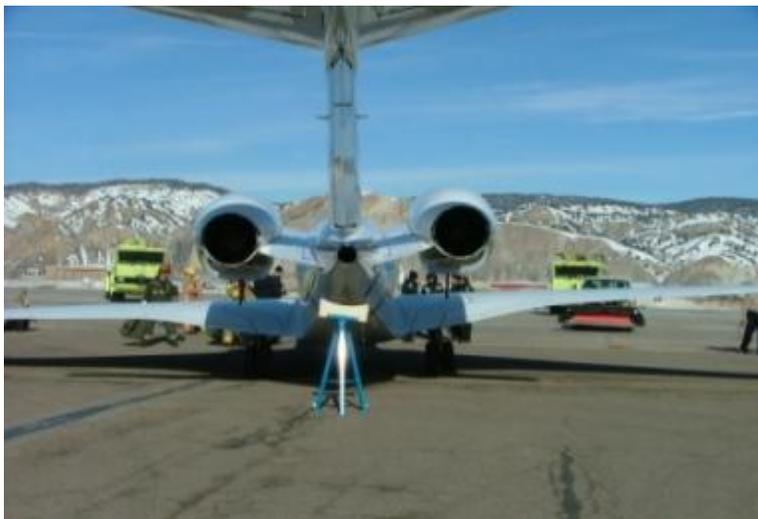
Figure 8. Tail Stand Attached to a Citation Jet During Recovery Efforts

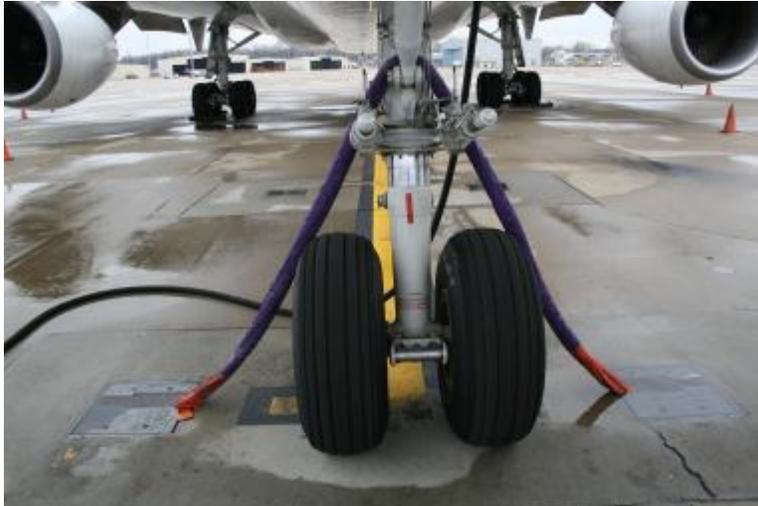
Ramps. Most FedEx ramps and some other cargo ramps are equipped with nose tie-down positions, located at designated aircraft parking locations on which freighter aircraft are loaded and unloaded. If a fire occurs when the aircraft is at one of these locations, the nose landing gear is either already tethered or can be tethered to the ramp, preventing tail tip. Figure 9 shows a FedEx MD-11 with the nose landing gear tethered to a tie down on the ramp at their Global Super Hub at Memphis International Airport.

Figure 9. A FedEx MD-11 at Memphis International Airport With Nose Landing Gear Tie Down

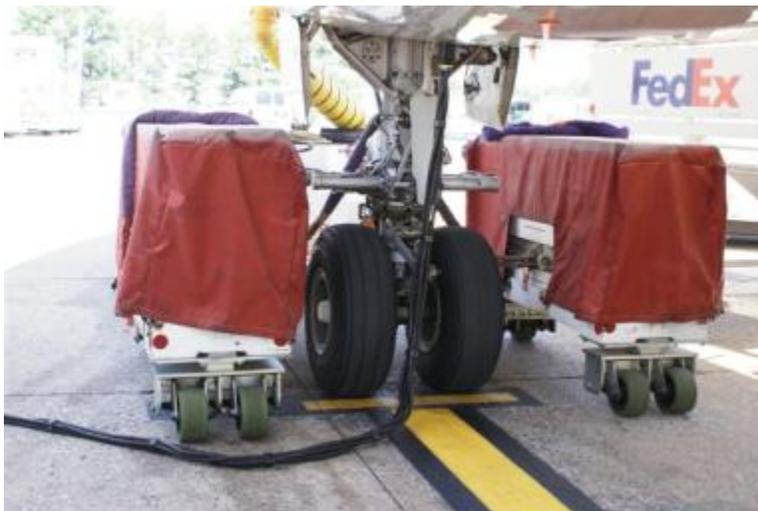
Counterbalances. Another system that may be available at an airport is a portable anchoring device nicknamed the Pet Rock. The Pet Rock used by FedEx at Dulles International Airport, as shown in figure 10, uses heavy counterbalances to hold the nose landing gear in position, thereby preventing a tail tip. If available, the use of this type of device can be an effective method to prevent a tail tip. This device is common at airports with FedEx operations, but may not be available at other stations. Other cargo operators may have devices that serve a similar function, such as an aircraft tug.

Figure 10. A FedEx Pet Rock Portable Anchoring Device at Dulles International Airport

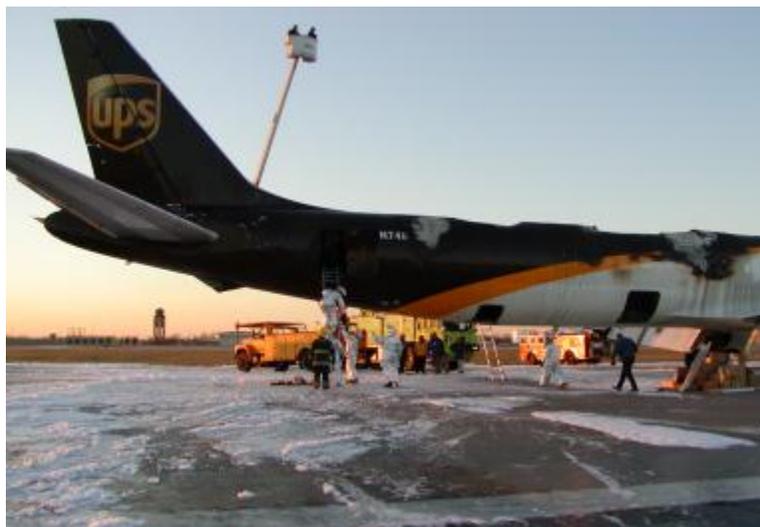
Figure 11 shows PHL ARFF and other emergency response personnel walking under and around the rear of the aircraft. Although at this point in the incident, the aircraft may have been declared safe and free from hazards associated with the fire, the photograph shows the length of unsupported fuselage aft of the main landing gear. Even if water was not present, additional structural failure, such as the burnthrough area on the top of the fuselage, can reduce the structural integrity of the fuselage, making a tail tip or fractured fuselage possible.

Figure 11. United Parcel Service Flight 1307 After the Fire was Extinguished
(Courtesy of the Philadelphia Fire Department)

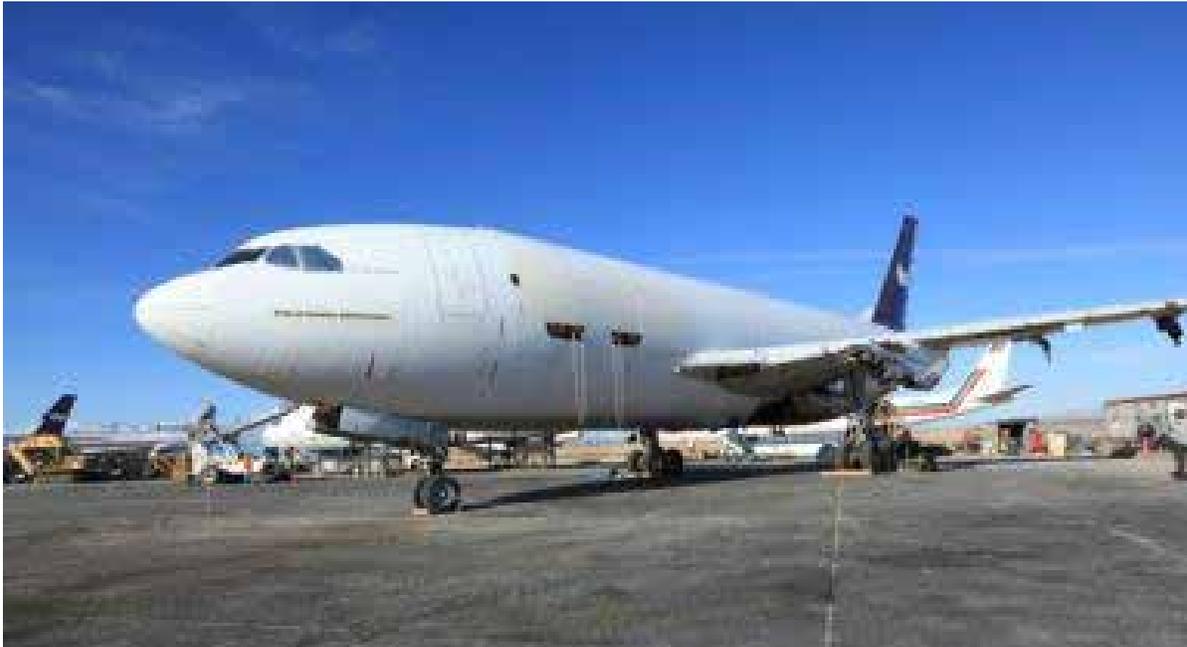
The test aircraft, shown in figure 13, was an A310-203F donated by FedEx. This aircraft is frame number 254, delivered June 1, 1983, and first flew for Lufthansa as a passenger aircraft. FedEx acquired the aircraft on July 18, 1994, and then converted the aircraft to a freighter aircraft with tail number N407FE. After finishing the aircraft's flight life, FedEx decommissioned the aircraft at the Southern California Logistics Airport in Victorville, California. FedEx harvested many of the aircraft's parts, including engines and electronic components, to support the remainder of the FedEx A310 fleet. At the completion of the salvage process, FedEx transferred ownership of the aircraft to the FAA for use in the FAA ARFF Research Program full-scale cargo fire testing. Different extinguishing tactics were tested with cargo containers using three different test zones (figure 14). The first test zone was in the forward part of the main cargo compartment; the second test zone was in the aft section of the main cargo compartment; and the third zone was in the forward lower cargo compartment.

Figure 13. The FAA A310 Test Aircraft

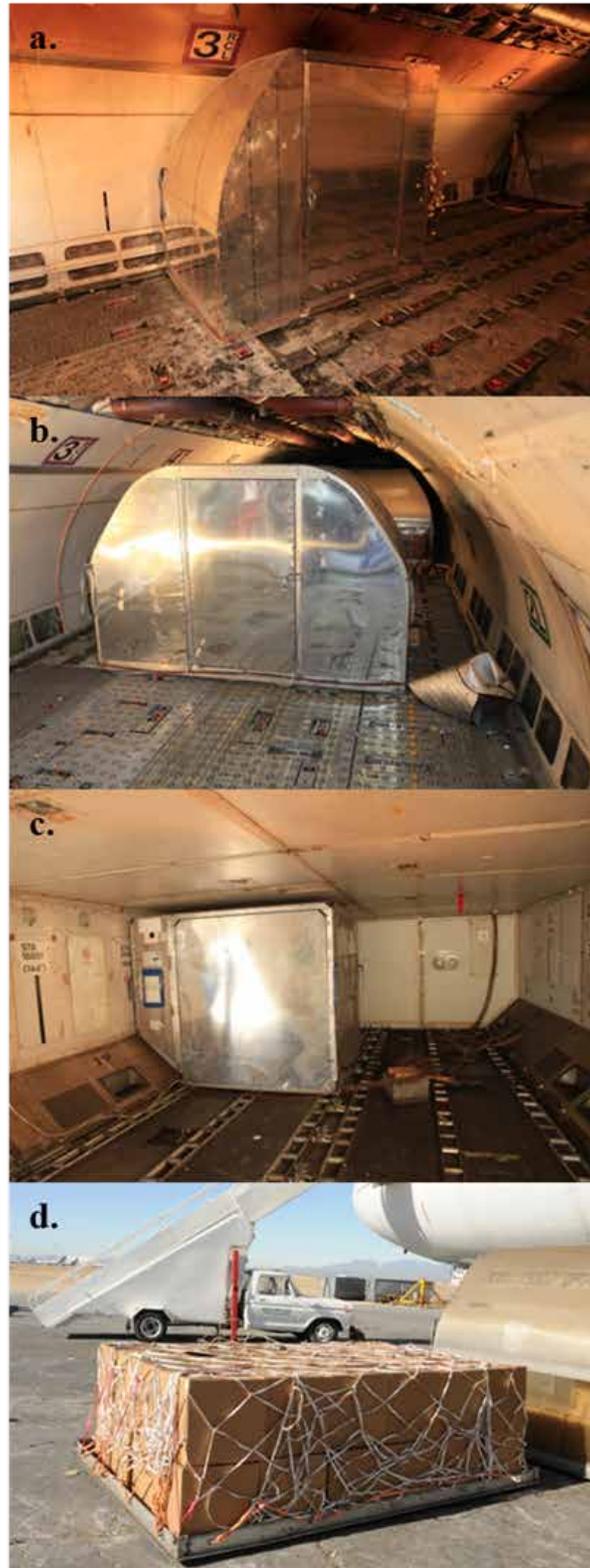
Containerized cargo is transported within unit load devices (ULD), which are generally either enclosed cargo containers or open pallets. Specialized ULDs are used to transport livestock, racehorses, and wild animals. The ULD containers are manufactured in a variety of sizes and shapes and are specified for particular aircraft by the carrier. The International Air Transport Association designates a three-letter code classification to identify each type of ULD. The first letter in the code gives the ULD category, the second letter describes the base dimension of the container, and the third letter describes the shape of the container. The tests used four different types of ULD containers, as shown in figure 15. A modified half section of an AAY ULD container simulated a half-width container (figure 15(a)). An intact AAY ULD container represented a full-width container (figure 15(b)). Lower cargo compartment tests used an LD3 ULD container (figure 15(c)). The base of an AAY container was used to represent a pallet ULD (figure 15(d)).

Figure 15. (a) A Half-Width ULD Container, (b) a Full-Width ULD Container, (c) an LD3 Container, and (d) a Pallet

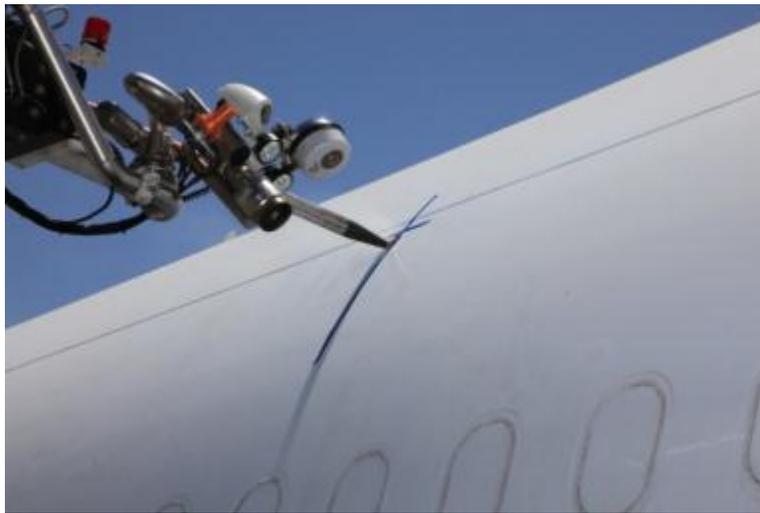
Two different HRET/ASPEN technologies were used to apply water into the aircraft through the ASPN. The first was the FAA Oshkosh Striker[®] with a Snozzle[®] 652 HRET system, shown in figure 16. This HRET consists of a 65-foot boom with two high-flow turrets and an ASPN. The ASPN attaches to the end of the boom and rotates into position through a hydraulic servo. It then penetrates the aircraft through the extension of the HRET boom. This ASPN can apply agent at a minimum flow rate of 250 GPM. The second HRET technology used was the Rosenbauer Stinger[®] mounted on a Panther vehicle, shown in figure 17. The Stinger[®] HRET has a 54-foot boom. It also has an ASPN attached to a lance and creates a 250-GPM spray. The piercing lance is retracted inside the tube when not in use to protect the piercing tip. The lance is hydraulically fired with amplified hydraulic flow from the three hydraulic accumulators.

Figure 16. Snozzle[®] 652 HRET

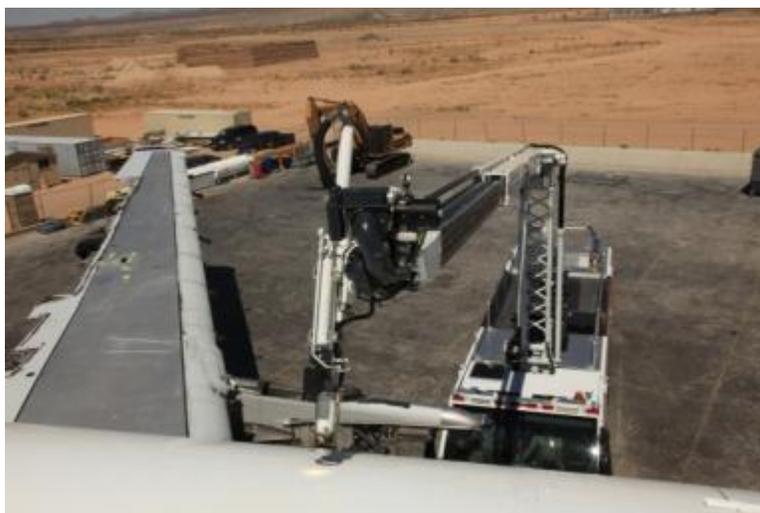
Figure 17. Rosenbauer Stinger[®] HRET

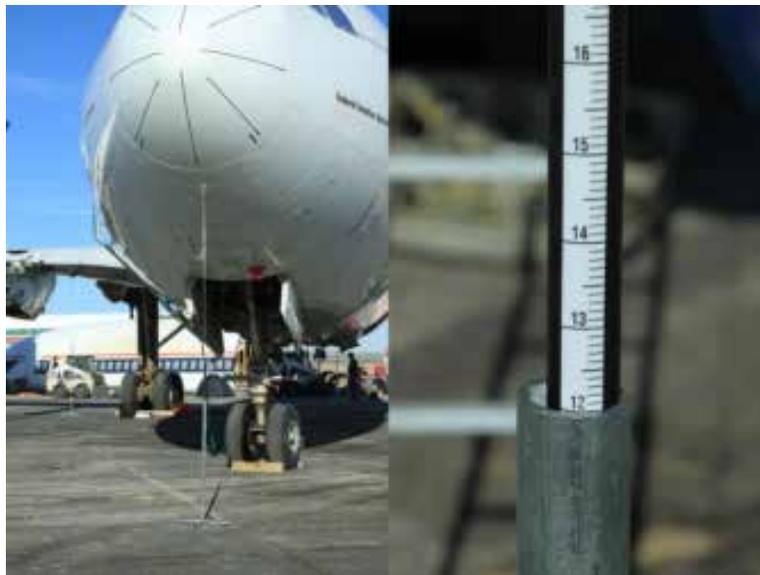
The A310 is a tail-heavy aircraft, and the removal or loss of the aircraft engines increases the chances of altering the aircraft's balance when water enters the aircraft. To monitor the aircraft weight and balance behavior, basic height measuring devices were installed around the test aircraft at four locations. Four sets of chains and ruled pipes, shown in figure 18, hung from locations underneath the aircraft. Two were placed at points on each of the wings, one from the tail, and one from the nose of the aircraft. The bottom of the chain attached to a pipe with an adhesive-backed rule running the length of it. The ruled pipe loosely hung into a larger pipe to create a measuring gauge. As the loading of the aircraft changed, the height readings on each pipe rule also changed. The team recorded height readings before and after each fire evolution. In addition, the team measured the amount of water applied to the fire to determine how water from that test fire affected overall weight and balance behavior of the aircraft.

(a) Chain attached to aircraft nose (b) Ruled pipe

Figure 18. Weight and Balance Measuring Devices

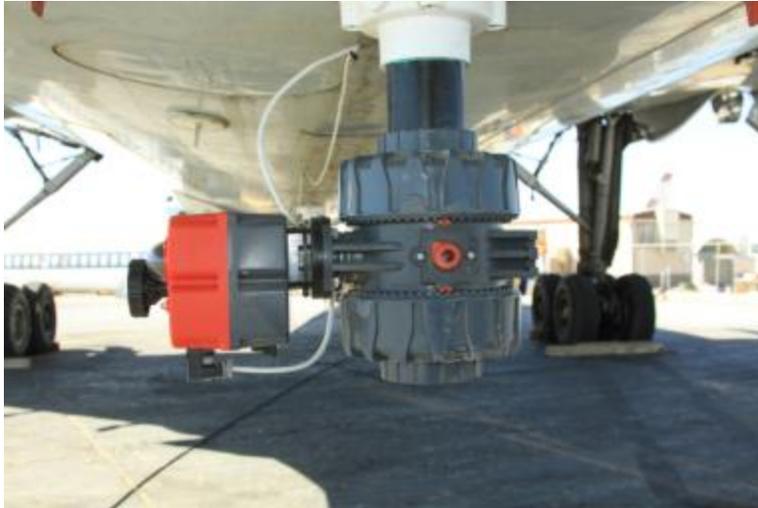
To control the outflow of water, all existing bilge drains were sealed. This simulated the clogging of the drain holes with washed-down soot and debris from a fire. Three external bilge drains, one shown in figure 19, were installed in the bottom of the aircraft and were used to control the flow of the remaining water inside the bilge. The bilge drains remained closed until the vertical displacement of the aircraft was measured.

Figure 19. Bilge Drain

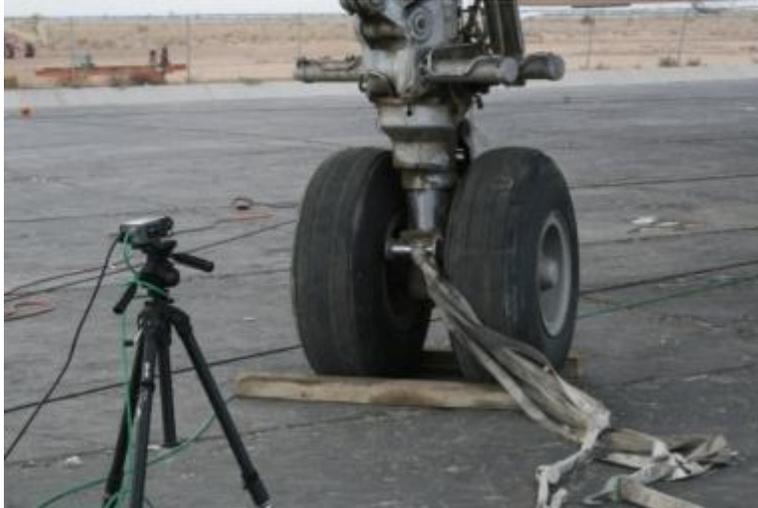
The nose landing gear strut served as the primary indicator for the forward-to-aft weight and balance behavior of the aircraft. As shown in figure 20, prior to introducing any water, the direction of the nose landing gear tires faced slightly to the left. The nose landing gear tire sidewalls bulged slightly, indicating that they carried the weight of the aircraft.

Figure 20. Nose Landing Gear Strut Prior to Forced Tail Tip

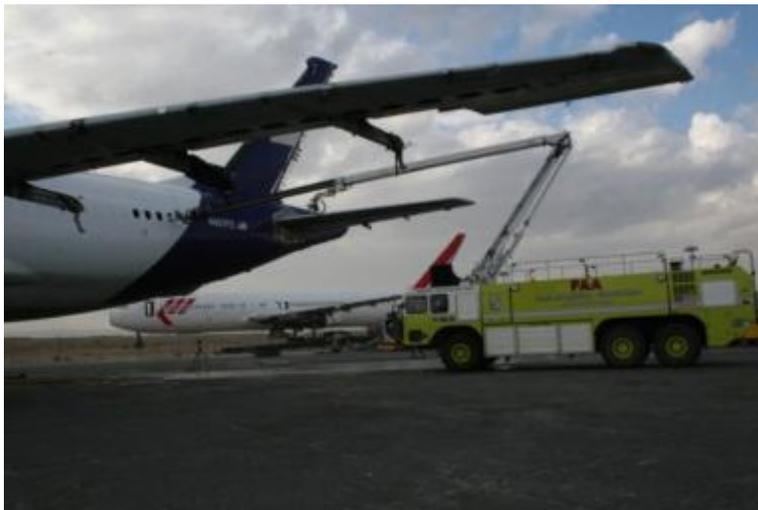
Before running the test, a safety area was established, which included the positioning of the ARFF vehicle, and the bilge drains were closed. The FAA Striker[®] was positioned on the port side of the aircraft, and the Snozzle[®] HRET was positioned pointing toward one of the rear, left windows of the aircraft. Research personnel removed the window blank to discharge water into the aircraft without having to penetrate the fuselage, as shown in figure 21. The ARFF vehicle was clear of all portions of the aircraft when it tipped. The main landing gears were all braced to the rear to prevent any backward roll. The FAA Striker[®] discharged its entire water supply of 2500 gallons into the aircraft. After that discharge, the nose landing gear had approximately 0.75 to 1 inch of exposed hydraulic piston.

Figure 21. The FAA Striker[®]

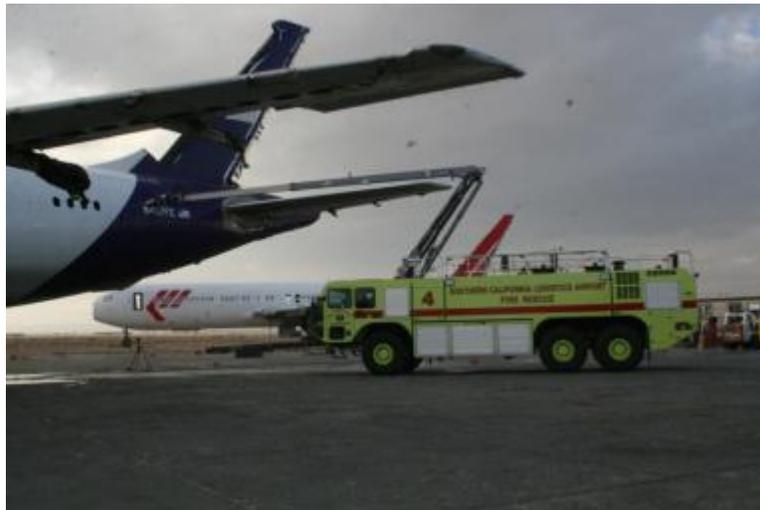
piston decreased. This could be because water in the main cargo compartment had time to spread throughout the aircraft. As shown in figure 22, Red 4 discharged 3000 gallons of water through the same window on the left rear side of the aircraft. When Red 4 completed its discharge, approximately 1 inch of exposed hydraulic piston in the nose landing gear strut was visible. The forwardmost bilge was then opened, and as water drained, the amount of exposed chrome steadily increased. After 4 minutes and 30 seconds with the forward bilge drain opened, over 10 inches of chrome was exposed, as shown in figure 23. At this time, research personnel opened the middle bilge drain. The amount of exposed hydraulic piston did not change significantly after the middle bilge drain was opened and the forward bilge was completely drained.

Figure 22. The SBCFD Red 4 Discharging

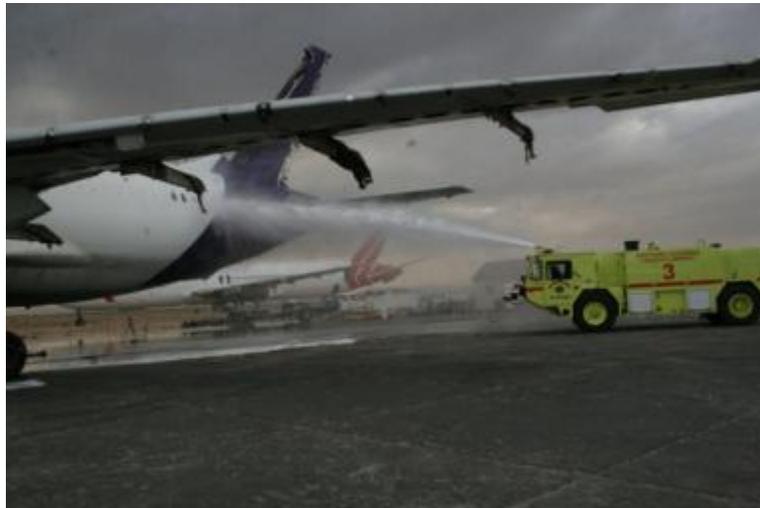
Figure 24. The SBCFD Red 3 Discharging

As shown in figure 24, SBCFD Red 3 provided the final discharge. This vehicle had approximately 700 gallons available. Since it was not equipped with an HRET, discharge continued using the roof turret into the window opening. Due to the method of water application, the amount of water that actually made it into the aircraft cannot be accurately determined, only estimated. At the conclusion of the discharge, the nose landing gear was slightly off the ground. This was evident when the nose landing gear centered itself from the slight left turn position after the weight of the water in the aft section reduced the vertical load on the nose landing gear.

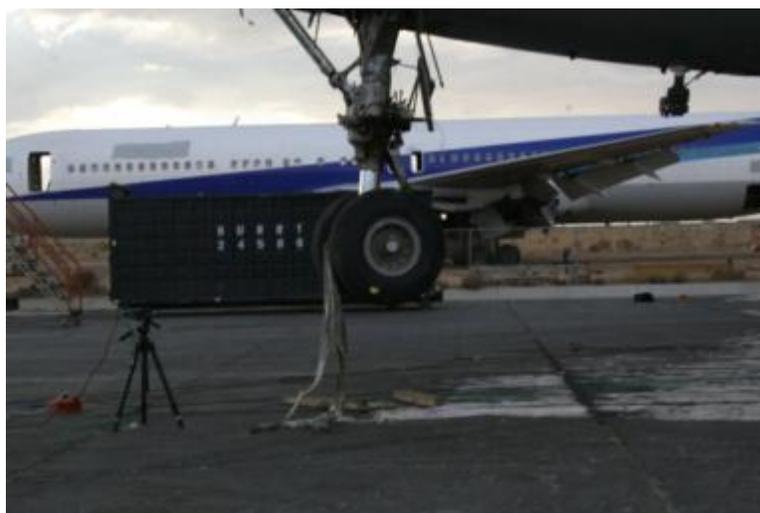
Figure 25. Nose Landing Gear Rising

After a few seconds, the aircraft slowly began to tip. The motion was not violent or rapid, but rather a gradual change in the incline. As shown in figure 25, the nose landing gear lifted from the ground. When the tail hit the ground, it made a loud thump, bounced a little, and then settled, as shown in figures 26 and 27.

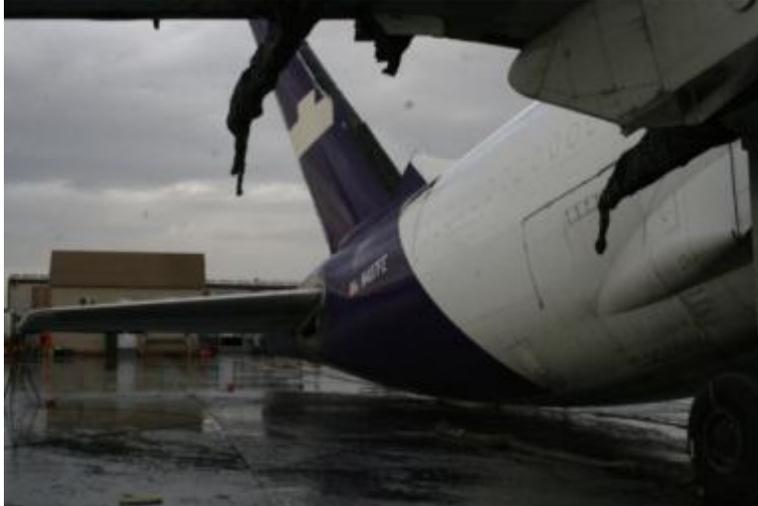
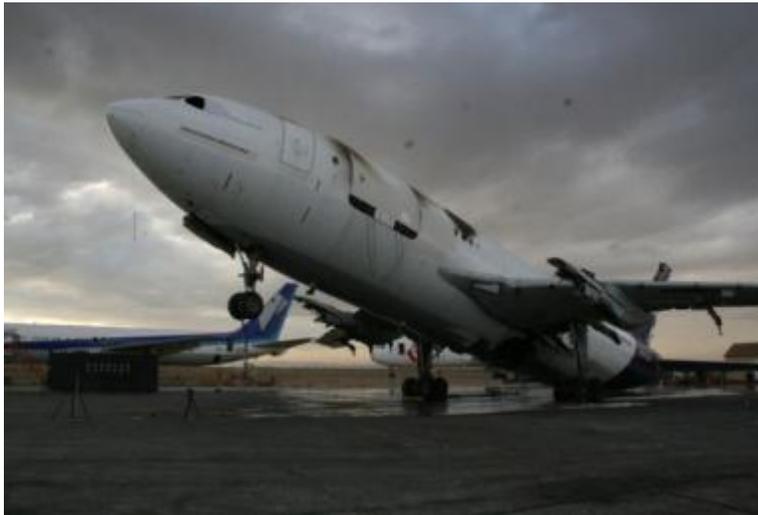
Figure 26. Tail Coming to Rest

Figure 27. Full View of Tail Tip
