DOT/FAA/AR-99/11

Large Engine Uncontained Debris Analysis

May 1999

Final Report

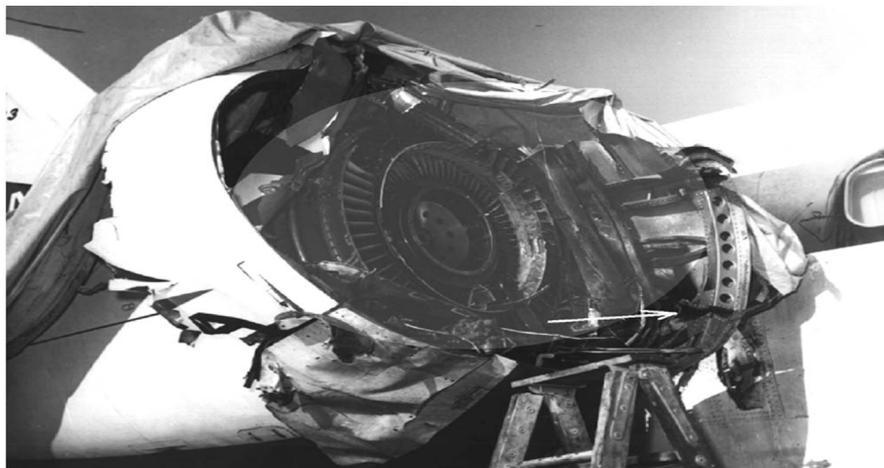
FIGURE 4-12. FAN DISK DAMAGE

For fan disk damage from a disk failure (shown in figure 4-12), figure 4-13 shows the basic trajectory angles to range from +5 and -5 degrees. A 100% normalized disk fragment is used to model fan disk debris. Initial energy levels are near 100,000 ft lbf.

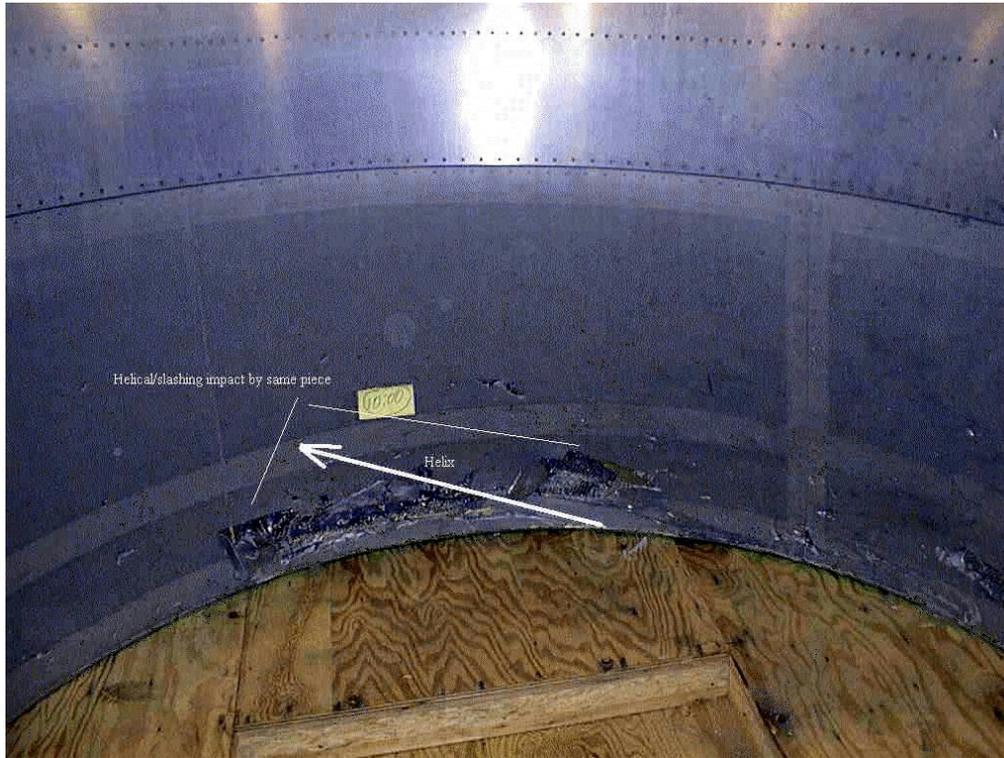
FIGURE 4-17. FAN BLADE HELICAL TRAJECTORY

For the aft trajectory angles, the debris must pass through the engine case and cowl. For the forward trajectories, however, there are two primary failure modes to consider: (1) helical motion of a blade tip upon fracturing against the containment ring and (2) particles which are reingested and then kicked forward after impacting the fan rotor (figure 4-17).

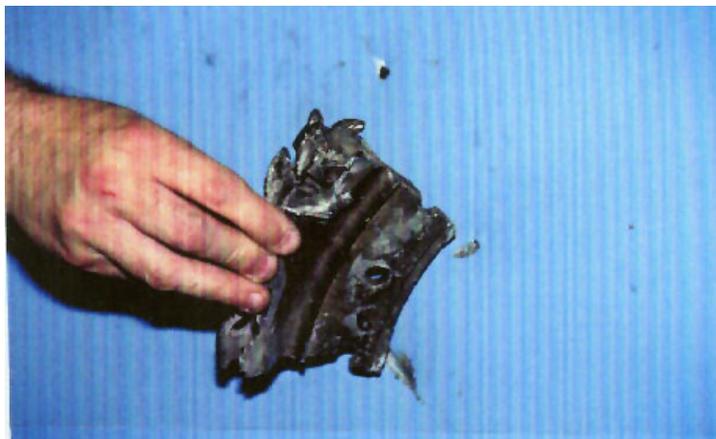
FIGURE 4-28. COMPRESSOR DISK FRAGMENT AFTER PASSING THROUGH THE FUSELAGE

Figure 4-28 shows a compressor disk fragment after passing through the fuselage. Figure 4-29 shows a very tight trajectory band of 5 to -5 degrees for disk debris. Initial energy levels are near 25,000 ft-lbf. These levels are similar to the fan blade energy levels presented earlier (figure 4-6). Disk pieces, however, often enter the fuselage edgewise making them far more likely to penetrate aircraft structure.
