DOT/FAA/AR-99/71

Full-Scale Tests of Lightweight Fragment Barriers on Commercial Aircraft

November 1999

Final Report

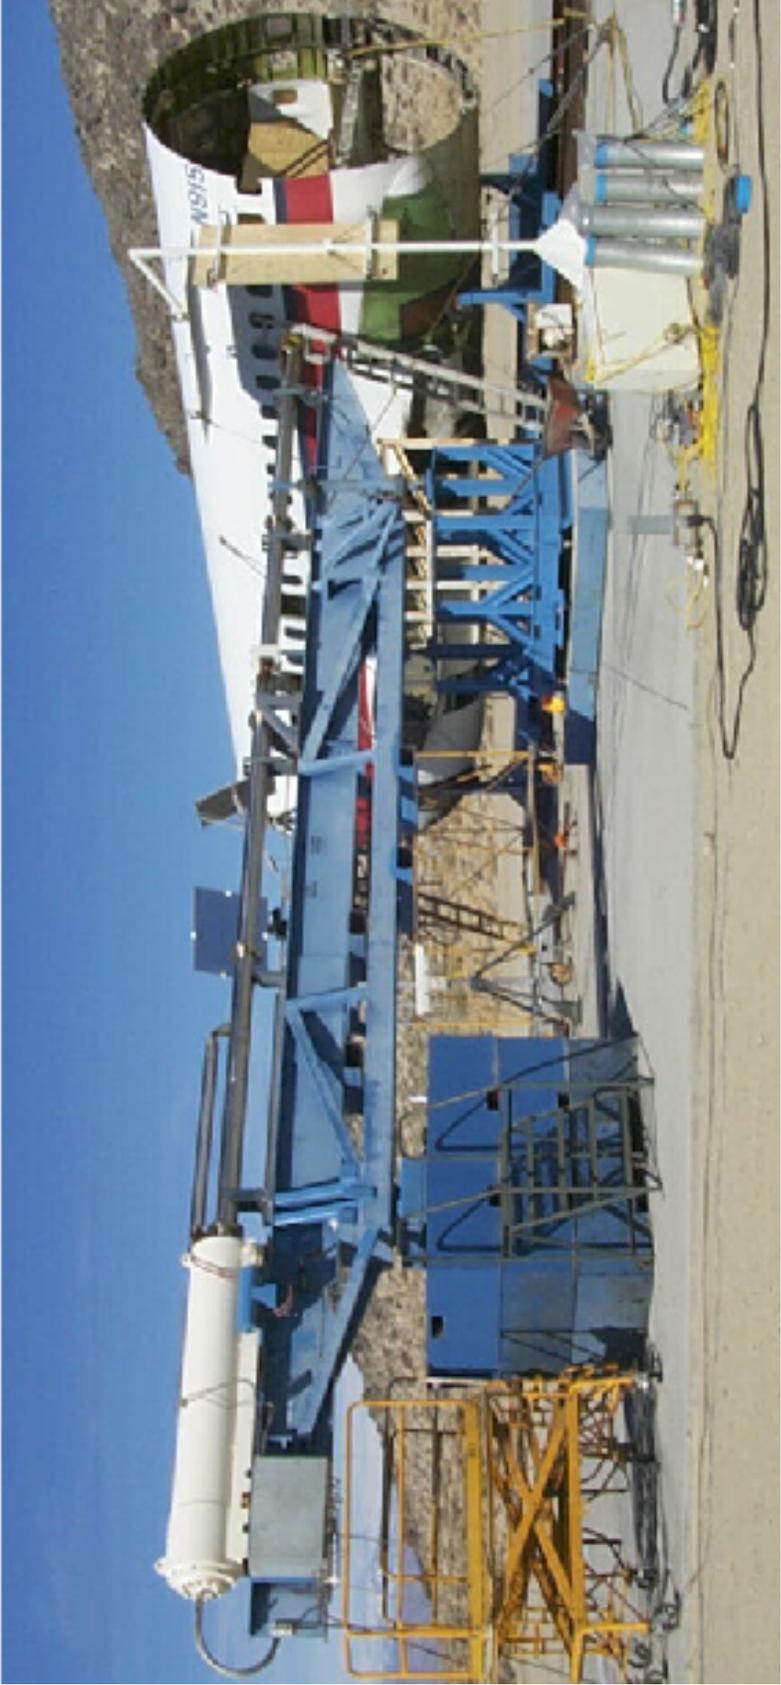
FIGURE 1. SIX-INCH BORE GAS GUN AND AIRCRAFT FUSELAGE SECTION AT CHINA LAKE FOR EVALUATING ENGINE FRAGMENT BARRIERS

The fragments were accelerated with a 6-in. bore gas gun against an aircraft fuselage section at the NAWC–China Lake test facility (see figure 1). The fuselage was mounted on a structure that could rotate the fuselage about its axis and translate it along its axis, to precisely site the impact. The impact locations were chosen to avoid fuselage frames (see figure 2).

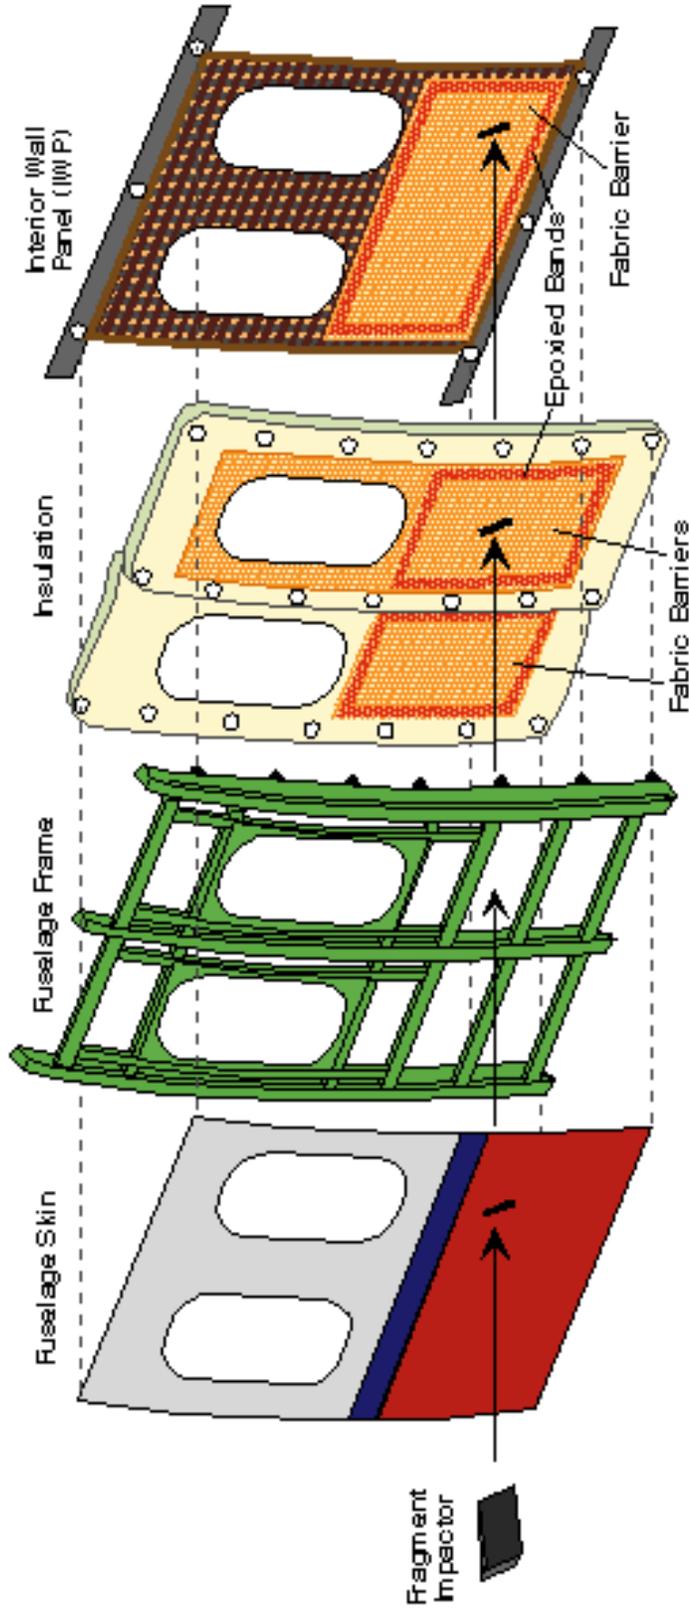
FIGURE 2. EXPLODED VIEW OF FUSELAGE WALL SHOWING LOCATIONS OF FABRIC FRAGMENT BARRIERS

The exploded view of the fuselage wall, figure 2, shows the locations of the ballistic fabric with respect to the aluminum fuselage skin, the insulation packet, and the interior wall panel (IWP). The fabric was attached with glue around its periphery either to the outboard side of the insulation or the outboard side of the IWP, or both. Previous small-scale experiments showed that gluing the fabric only around the edges not only reduced weight compared to gluing down the whole fabric, but enhanced energy absorption. Up to three fabric plies were attached to the insulation packet, and for some tests, an additional ply was attached to the IWP. The Zylon 35 x 35 weave was the fabric used for most of the tests; Kevlar 32 x 32 weave and Spectra 32 x 32 weave were used in one test each.

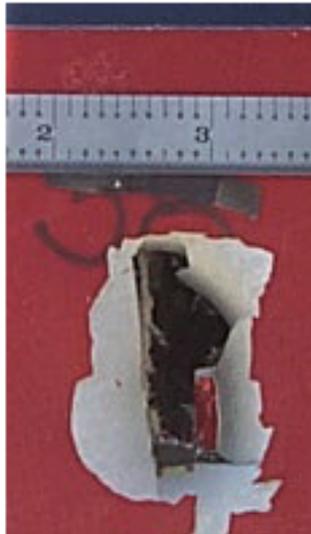
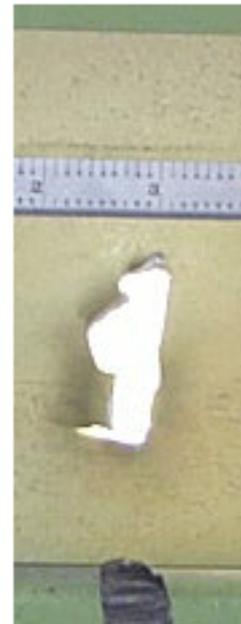
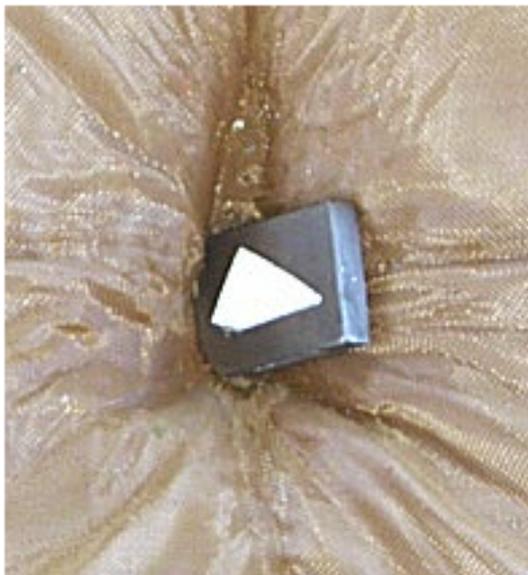
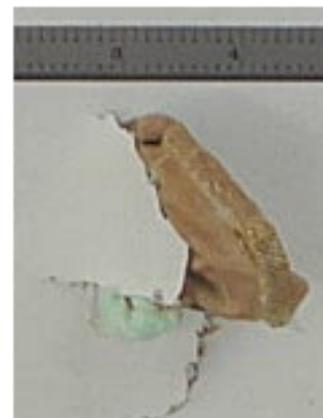
Hole in
Fuselage Skin

Incomplete Penetration of Impactor

FIGURE 3. POSTTEST PHOTOS FROM TEST 39
(25-g (0.555 lb) blunt-edged fragment simulator (FS) at 192 m/s (631 f/s)
1-ply Zylon 35 x 35 fragment barrier glued to insulation.)

Figures 3 and 4 show photographs of the fragment, fuselage skin, and IWP for Test 39 with the small fragment and Test 50 with the fan blade fragment. In these two tests, the fragment was unable to completely perforate the fabric layers. The fabric-cloaked fragment broke through the IWP, but was arrested there. This fragment “capture” mechanism has important implications in designing lightweight barriers, as discussed below.

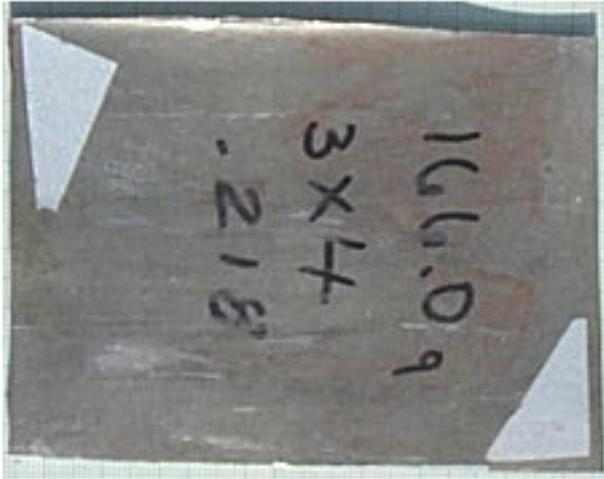
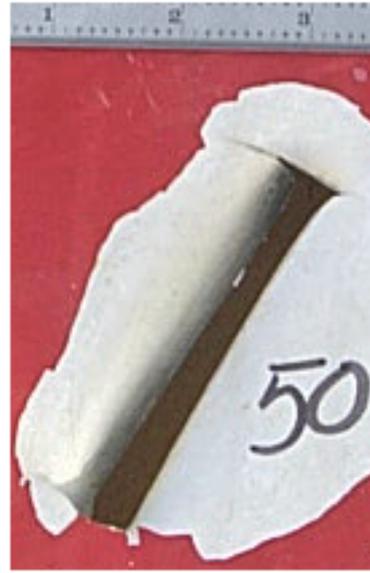
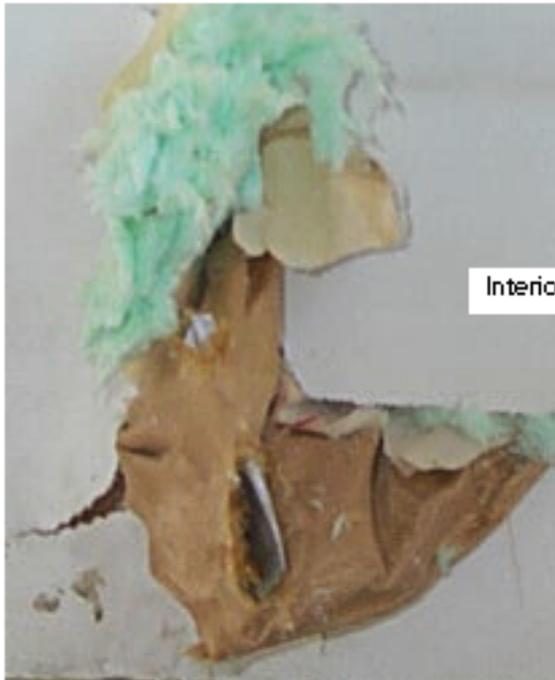
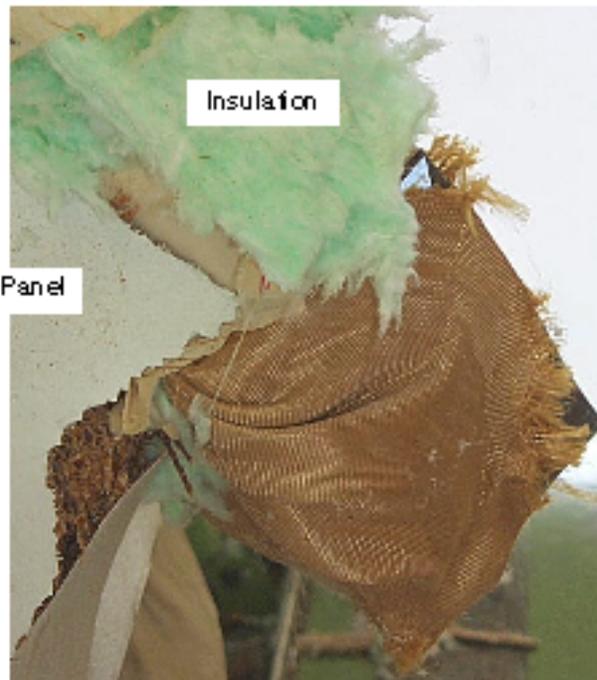
Hole in Fuselage Skin

Incomplete Penetration of Impactor

FIGURE 4. POSTTEST PHOTOS FROM TEST 50 (166-g (0.37 lb) sharp-edged fan blade fragment (FB) at 190 m/s (622 f/s) 3-ply Zylon 35 x 35 fragment barrier glued to insulation.)

A comparison of two tests with three layers of Zylon glued to the insulation (Test 51 with an additional layer glued to the IWP and Test 50 without the additional layer) shows that the additional layer on the IWP prevents the fragment from protruding as far through the IWP. However, since both barriers arrested the fragment, the tests did not establish whether an additional ply glued to the insulation would be more effective than the additional ply glued to the IWP.
